# REPORT OF RCRA COMPLIANCE EVALUATION INSPECTION

**R3 Energy**  
1722 210 Road  
Cottonwood Falls, Kansas 66845  
(620) 366-0964

July 23, 2013

U.S. ENVIRONMENTAL PROTECTION AGENCY  
Region VII  
Environmental Services Division

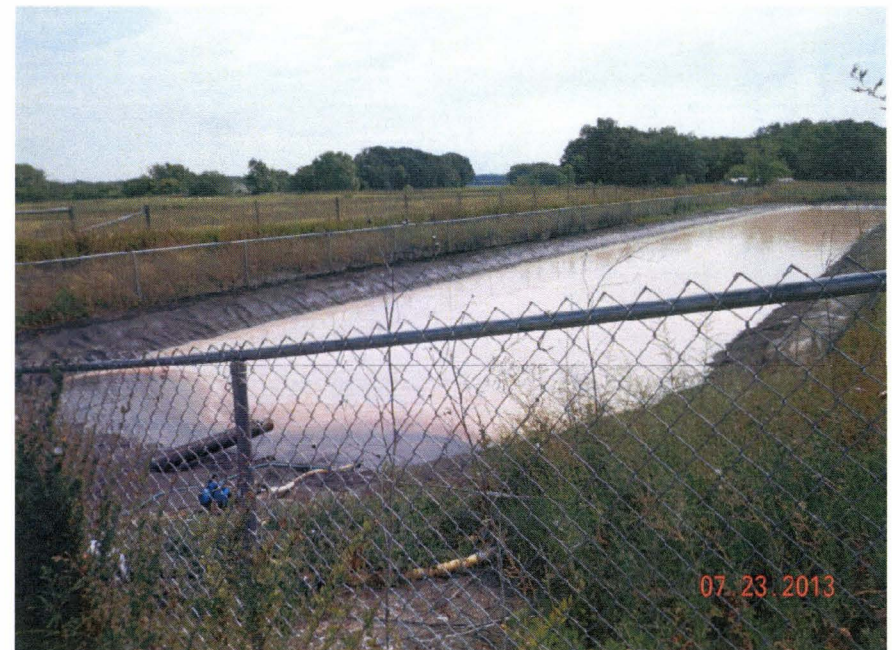
**PHOTO 2, 7/23/2013** – Retention Pond (facing NE) – Oil and several apparent aluminum beer cans in the pond.  
D. Newsome

As stated above in Section 4.3, at the time of shut down in December 2011, R3 Energy was discharging their wastewater into the on-site retention pond, decanting the separated oils back into the process and spreading the remaining pond water on-site (see attachment 6B for layout). Mr. McCalla and Mr. Shoults stated that when the facility shut down, it was shut down in such a way that someone could pick up right where they stopped. This included leaving samples on the lab bench (see photos 29 through 32), biodiesel chemicals on-site and wastewater in the retention pond. However, Mr. Shoults stated that the tanks did not contain any methanol as it was all consumed in the process.

After a heavy rain event, there was an oil release from the retention pond that contaminated the on-site soil, fire pond, and the neighbor's property. On 5/18/2013, EPA SUPR (Janice Kroone EPA contact)

After the above initial EPA oil removal from the retention pond, more oil was observed in the pond and was removed by R3 Energy (see EPA SUPR reports for more discussion). Mr. Shoults stated that since Ms. Kroone's remedial activity, they have removed additional oil from the retention pond three times, and it was also sent to Healey as feed stock. At the time of the inspection, I observed some oil on the west end of the pond (see photos 2 through 4). Mr. McCalla and Mr. Shoults stated that the oil is coming from the pond's liner when it rains. They stated that nothing is being added into the pond other than storm water. I observed the gate valve that Mr. Shoults identified to control flow from the facility's floor drains into the pond and it appeared closed as it was in the down position. I also observed several apparent aluminum beer cans in the pond. Mr. McCalla and Mr. Shoults did not know exactly how they got into the pond. Mr. Shoults stated that as of Sunday (7/21/2013), they started discharging 1000 gallons of wastewater per day (from 5:00 P.M. to 9:00 P.M.) from the retention pond to the POTW. Therefore, they have discharged 1000 gallons only twice, on 7/21/13 and 7/22/2013. Mr. McCalla and Mr. Shoults stated that once the water level in the pond is low enough, they will power wash the liner and hope this will eliminate any more oil from being accumulated in the retention pond.

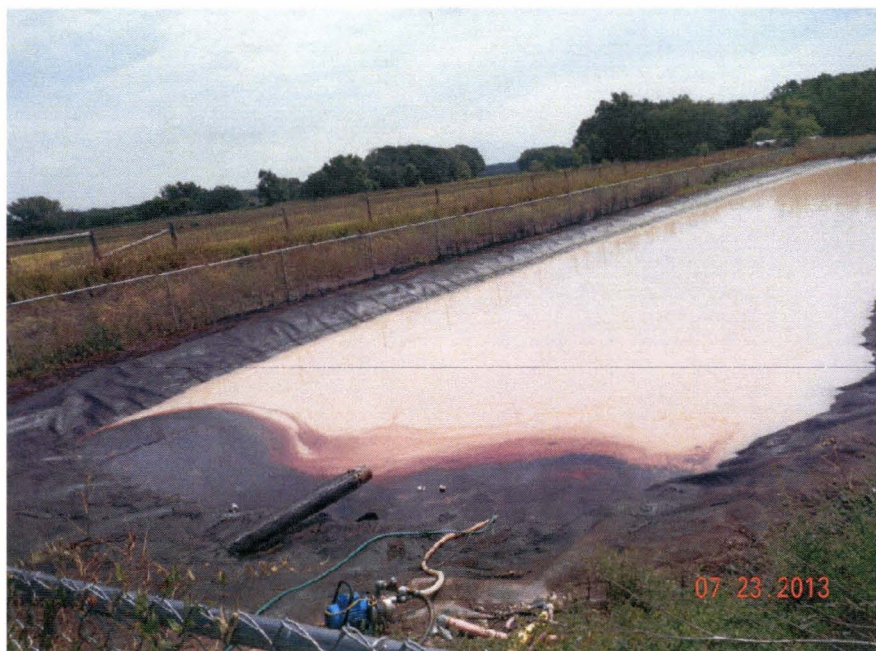
**PHOTO 3**, 7/23/2013 – Retention Pond (facing NE) – Oil and several apparent aluminum beer cans in the pond.

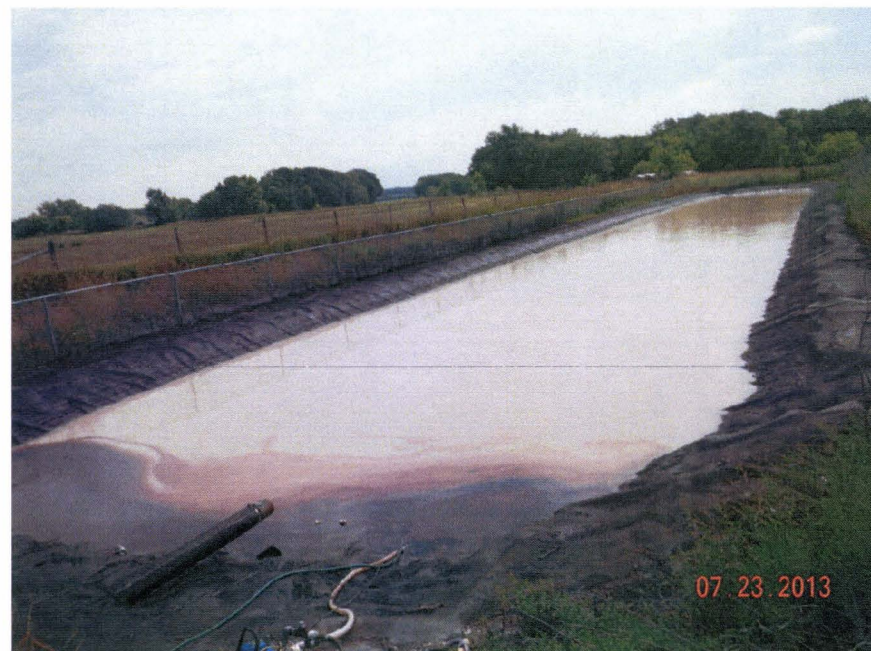
**PHOTO 4**, 7/23/2013 – Retention Pond (facing NE) – Oil and several apparent aluminum beer cans in the pond.

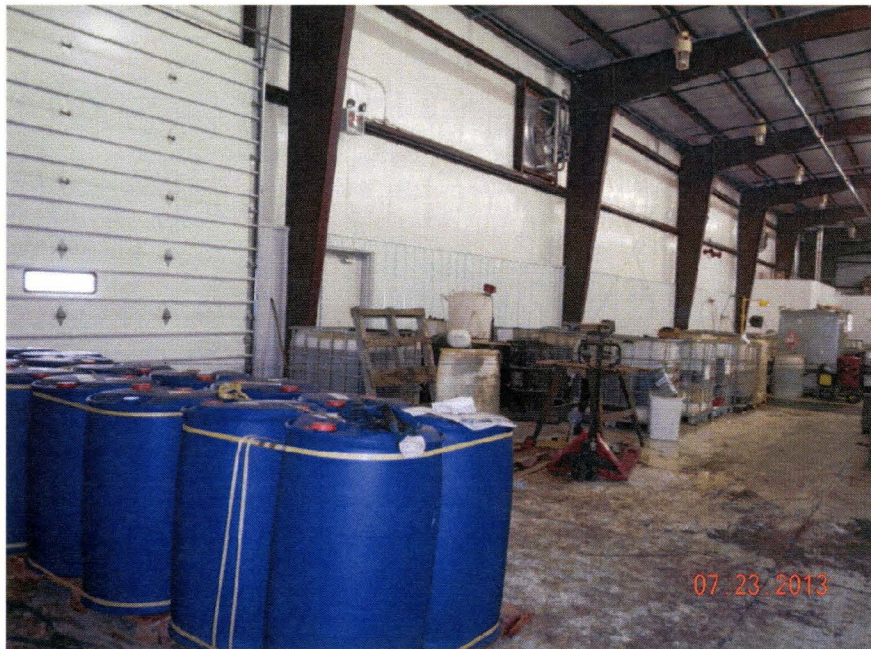
**PHOTO 7, 7/23/2013** – Remaining Chemicals On-site – Area includes 16 blue drums of unused sulfuric acid (report Section 4.5.2 Inventory Item #1) and containers of various other chemicals shown in photos 8 through 15. See attachment 6C for photo location. D. Newsome

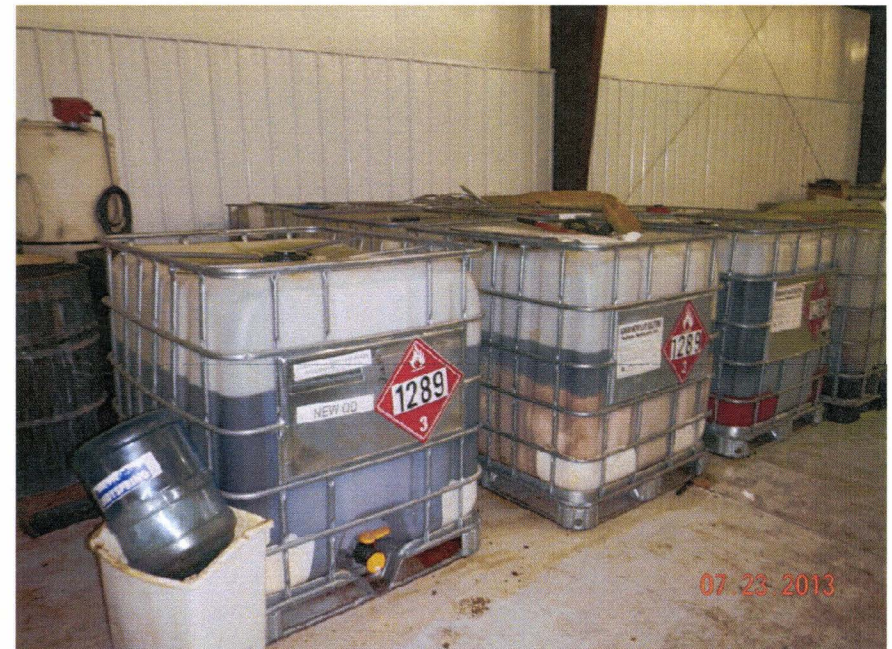
**PHOTO 8, 7/23/2013** – Remaining Chemicals On-site – Area includes report Section 4.5.1 Inventory Item #6a (soy oil/soap) and Section 4.5.2 Inventory Item #3 (oil to be processed). See attachment 6C for photo location. D. Newsome

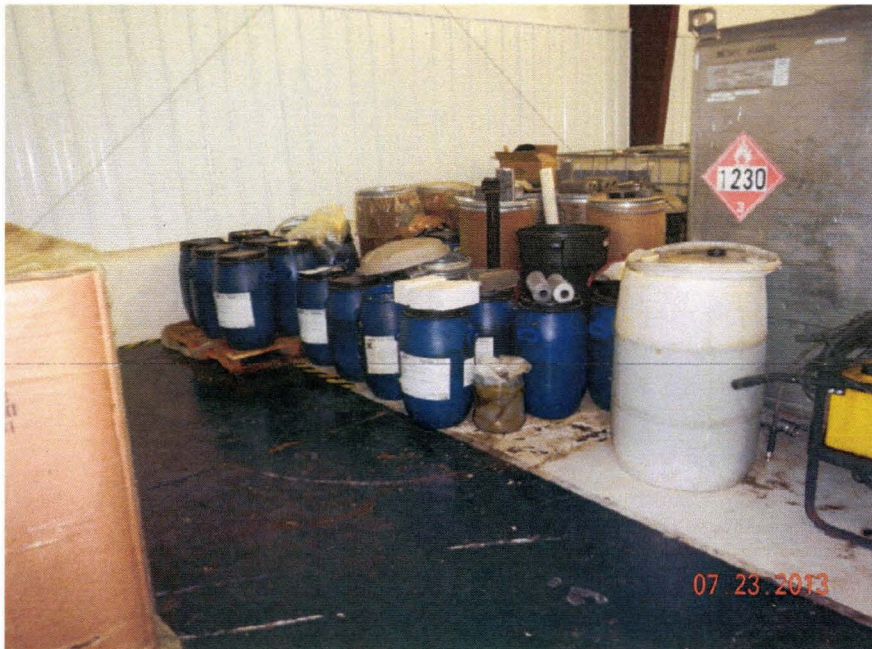
**PHOTO 9**, 7/23/2013 – Remaining Chemicals On-site – Area includes report Section 4.5.1 Inventory Item #7 (used filter resin) and Section 4.5.2 Inventory Item #3 (drum of oil to be processed). See attachment 6C for photo location. *D. Newsome*

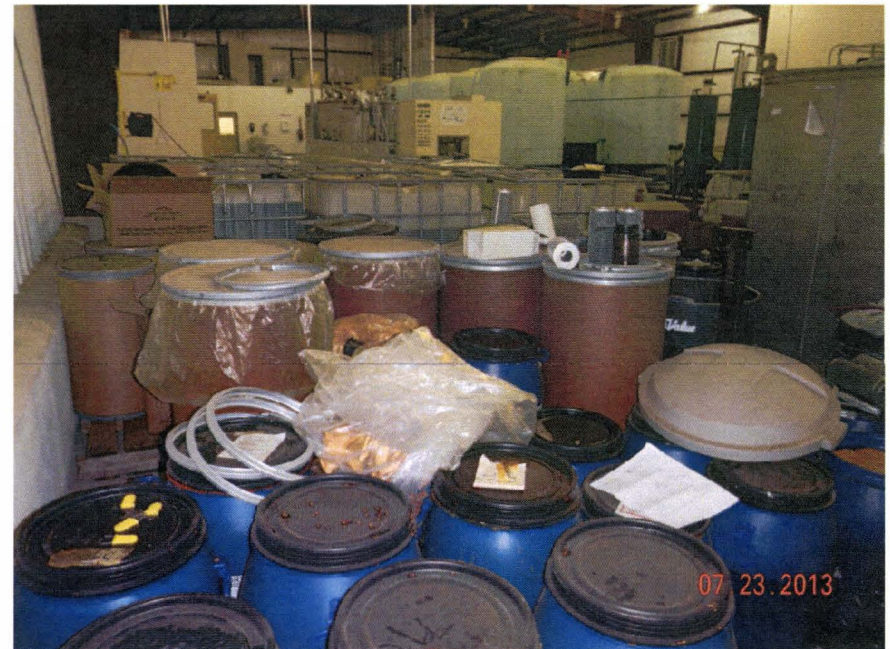
**PHOTO 10**, 7/23/2013 – Remaining Chemicals On-site – Area includes report Section 4.5.1 Inventory Item #6a (soy oil/soap) and #7 (used filter resin) and Section 4.5.2 Inventory Items #2 (sodium methyllate) and #3 (oil to be processed). Also, shown are three tanks used by EPA identified by Mr. McCalla and Mr. Shoults. See attachment 6C for photo location. *D. Newsome*

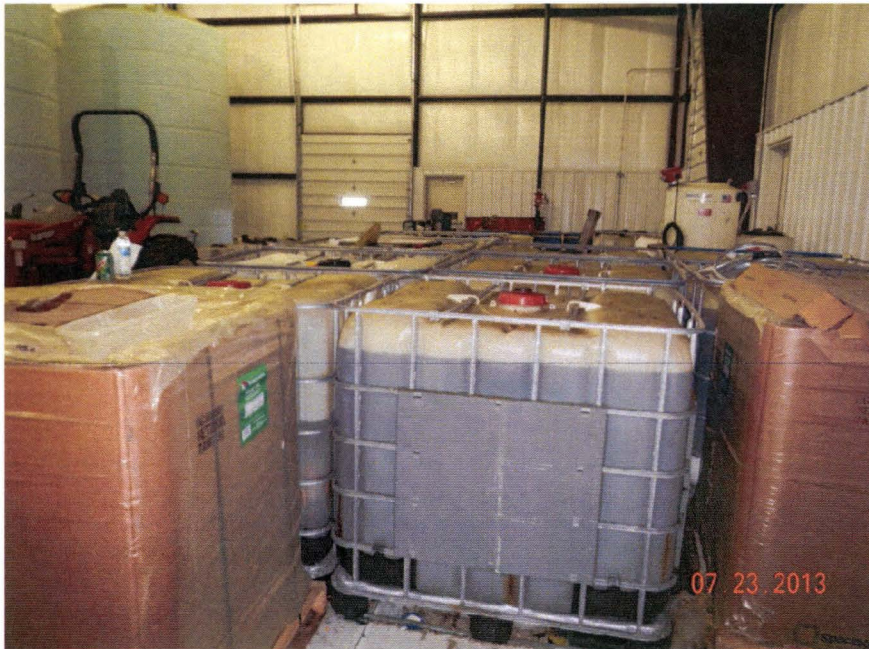
**PHOTO 11**, 7/23/2013 – Remaining Chemicals On-site – Area includes report Section 4.5.1 Inventory Item #6a (soy oil/soap) and Section 4.5.2 Inventory Items #2 (sodium methyllate) and #3 (oil to be processed). See attachment 6C for photo location. D. Newsome

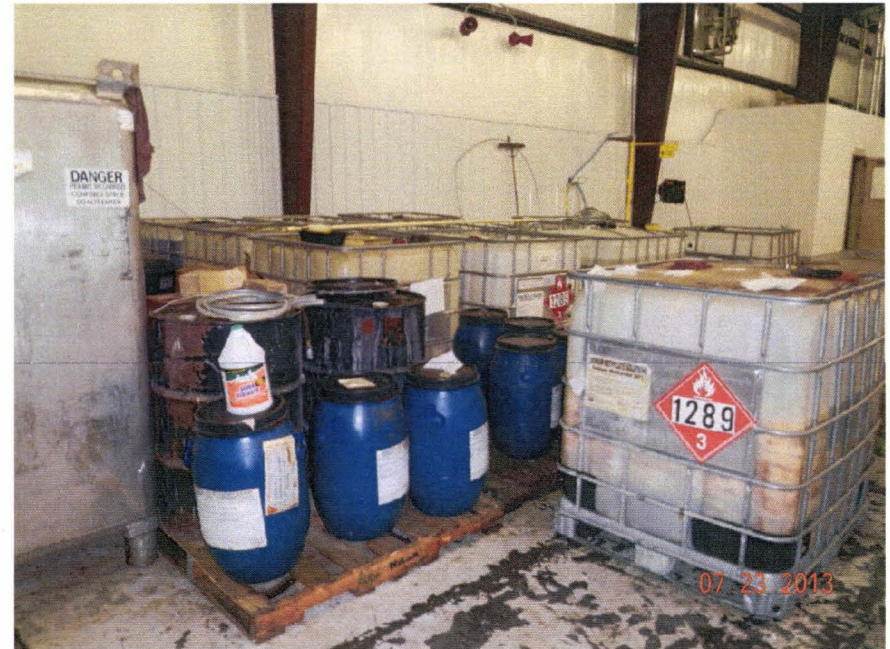
It should also be noted that inside the facility throughout the area near the process tanks, I observed the floor's protective coating peeling off and oily liquid/gel like puddles on the floor and in the floor seams

**PHOTO 12**, 7/23/2013 – Remaining Chemicals On-site – Area includes report Section 4.5.1 Inventory Items #6a and 6b (soy oil/soap) and #7 (used filter resin) and Section 4.5.2 Inventory Items #2 (sodium methyllate) and #3 (oil to be processed). See attachment 6C for photo location. D. Newsome

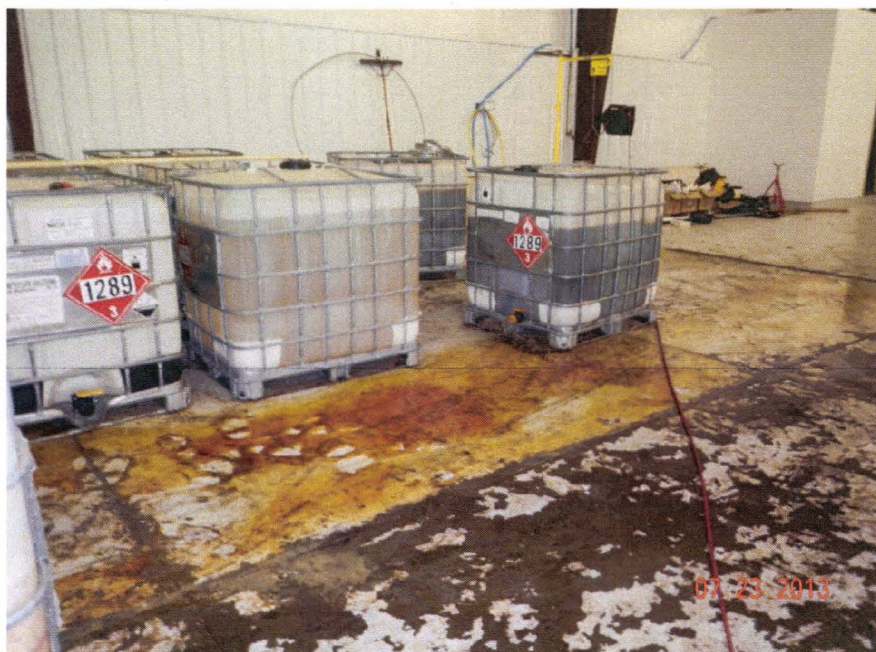
**PHOTO 13**, 7/23/2013 – Remaining Chemicals On-site – Area includes report Section 4.5.2 Inventory Items #2 (sodium methylate) and #3 (oil to be processed). Also, liquid/gel puddles on floor in area. See attachment 6C for photo location. D. Newsome

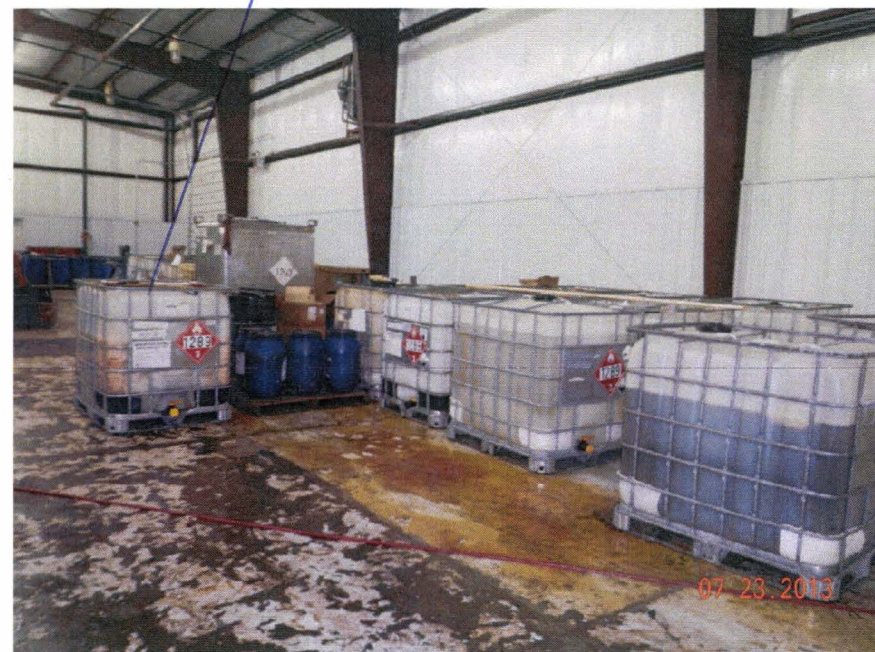
**PHOTO 14**, 7/23/2013 – Remaining Chemicals On-site – Area includes report Section 4.5.1 Inventory Items #6a and 6b (soy oil/soap) and #7 (used filter resin) and Section 4.5.2 Inventory Items #2 (sodium methylate) and #3 (oil to be processed). Also, liquid/gel puddles on floor in area. See attachment 6C for photo location. D. Newsome

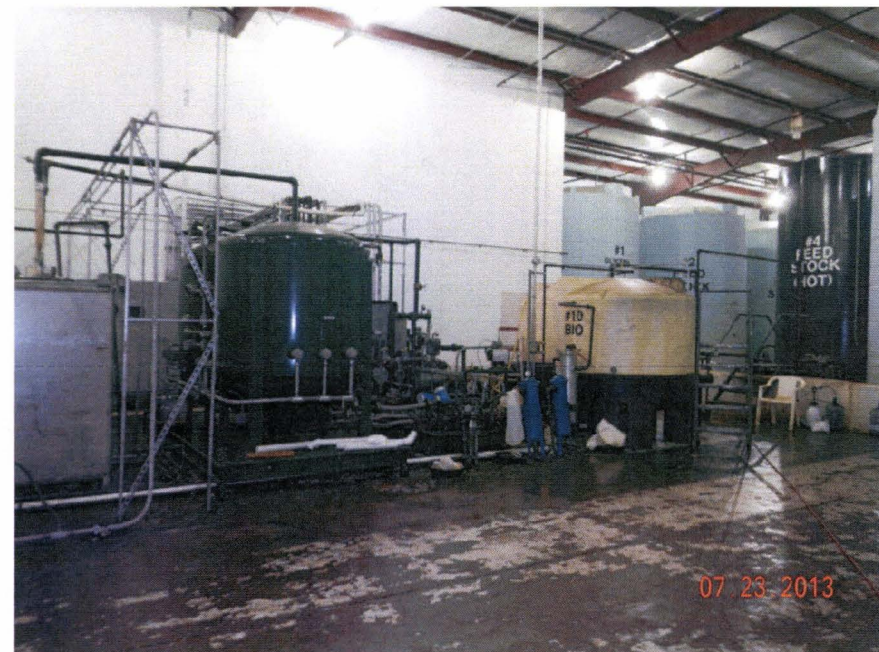
**PHOTO 16, 7/23/2013** – Old Processing Equipment including report Section 4.5.2 Inventory Items #4 (used filter socks). Also, liquid/gel puddles on floor in area. Close-up shown in photo 16. See attachment 6C for photo location. D. Newsome

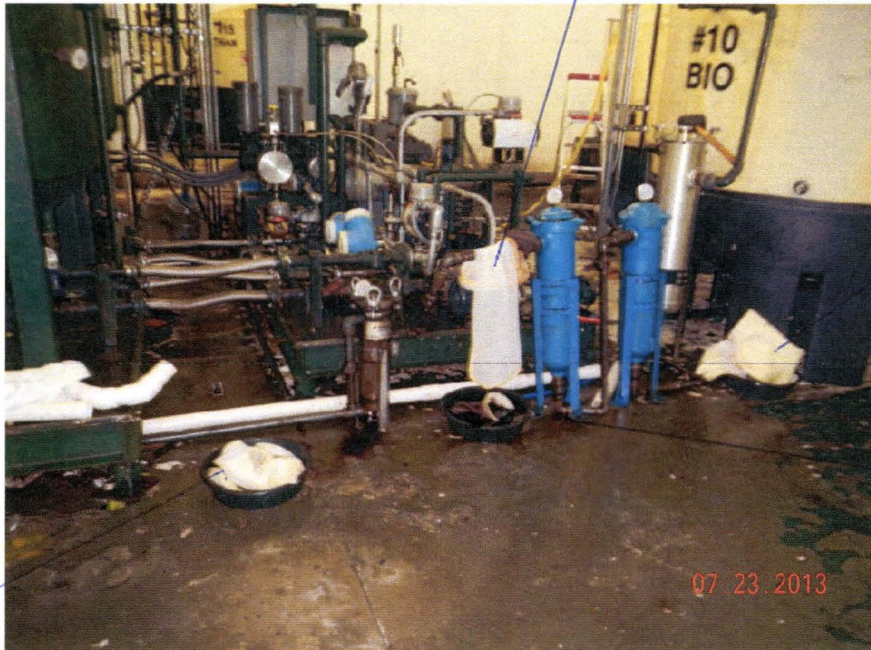
**PHOTO 17**, 7/23/2013 – Close-up of report Section 4.5.2 Inventory Items #4 (used filter socks) shown in photo 16. Also, liquid/gel puddles on floor in area. See attachment 6C for photo location. D. Newsome

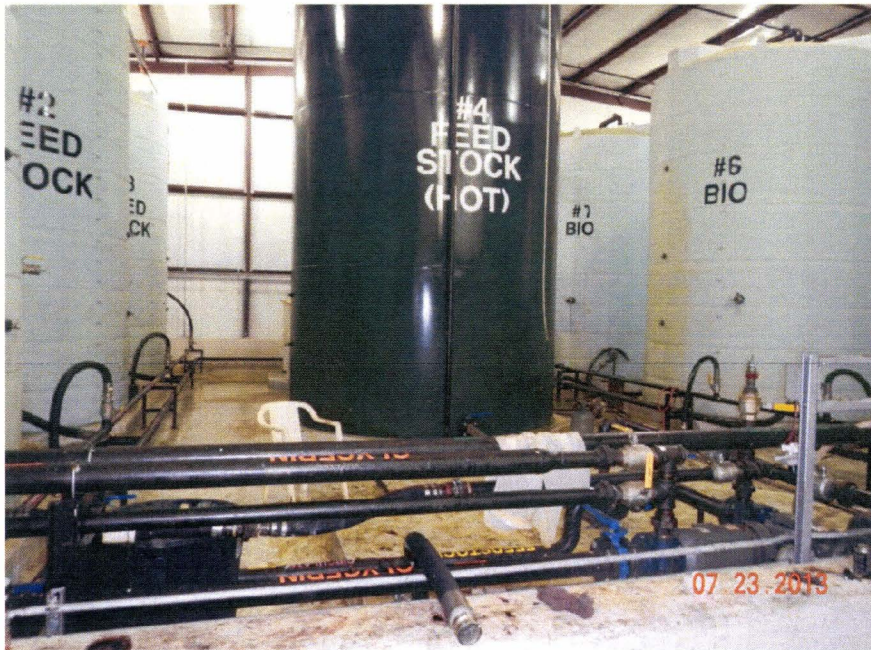
**PHOTO 19, 7/23/2013** – East Tank Storage Area, see attachment 6C for photo location. Also, liquid/gel puddles on floor in the tanks' containment area. D. Newsome *DN*

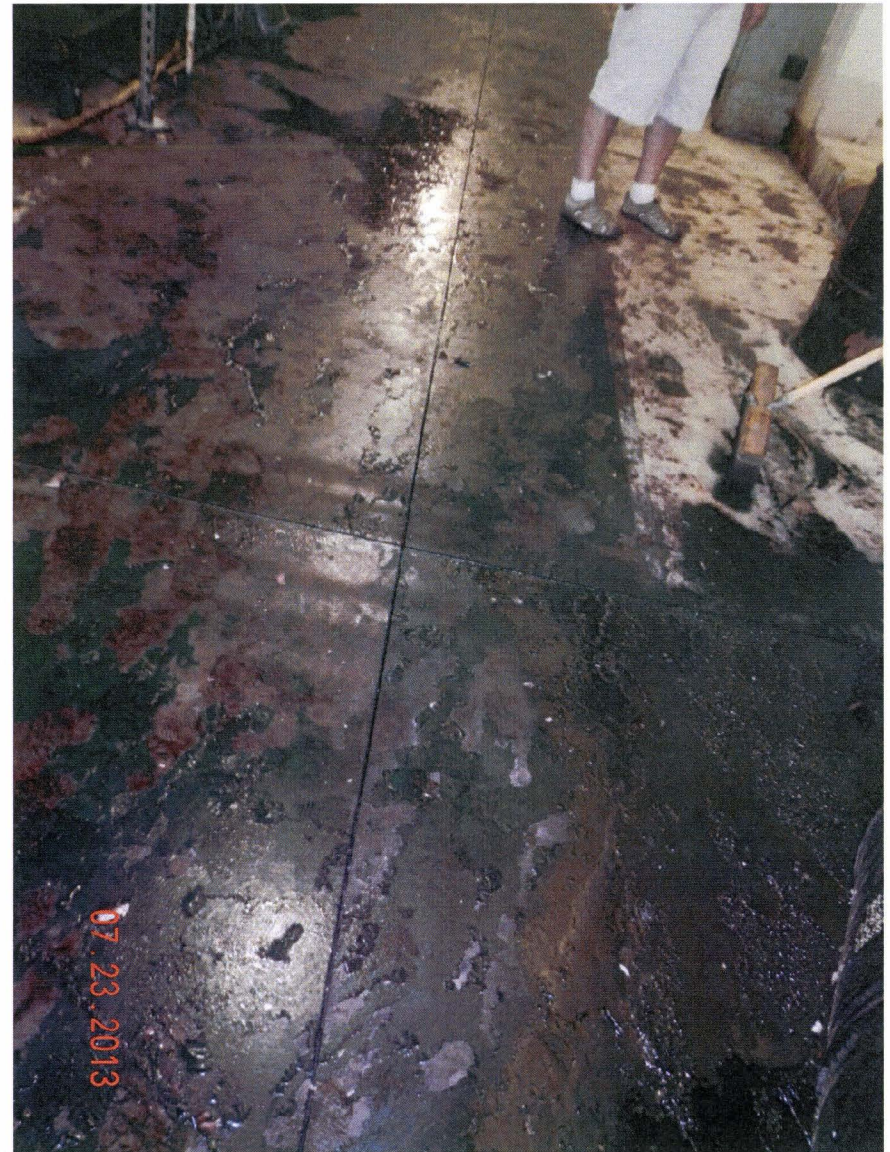
**PHOTO 20, 7/23/2013** – Puddles/spills on floor and in between floor seams, see attachment 6C for photo location. D. Newsome *DN*

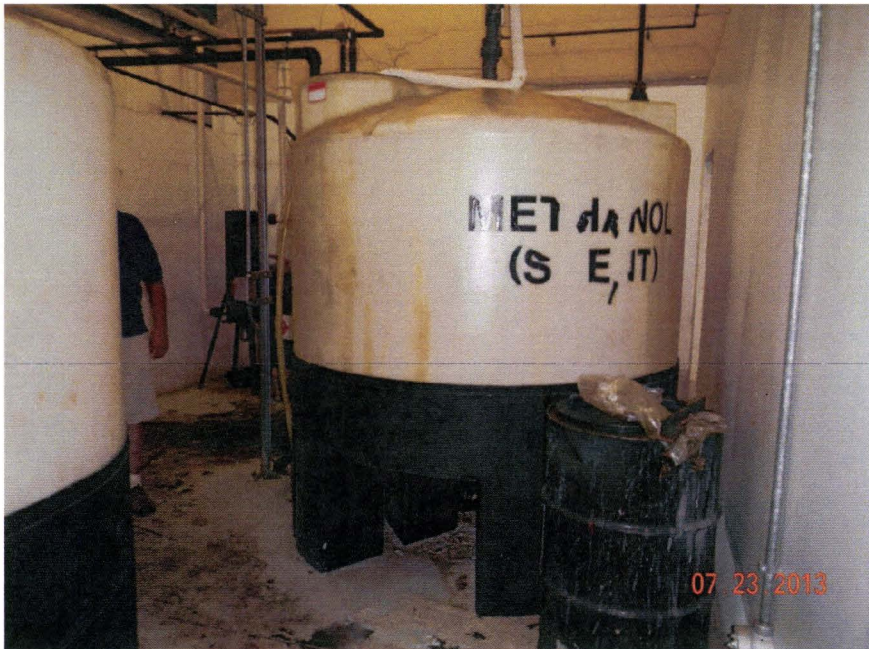
**PHOTO 21, 7/23/2013** – Methanol Storage Room – Used methanol tank where methanol vapors are vented from the process, condensed into a liquid and then reused in the process, see attachment 6C for photo location. Also, stains observed on the floor in room. D. Newsome *DN*

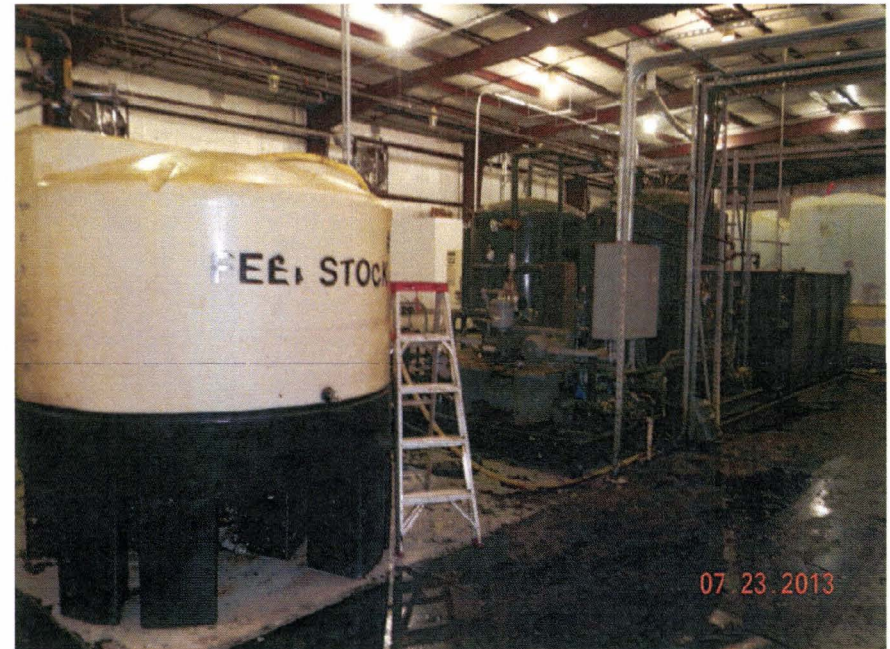
**PHOTO 22, 7/23/2013** – Old Processing Equipment. Also, liquid/gel puddles on floor in area. D. Newsome *DN*

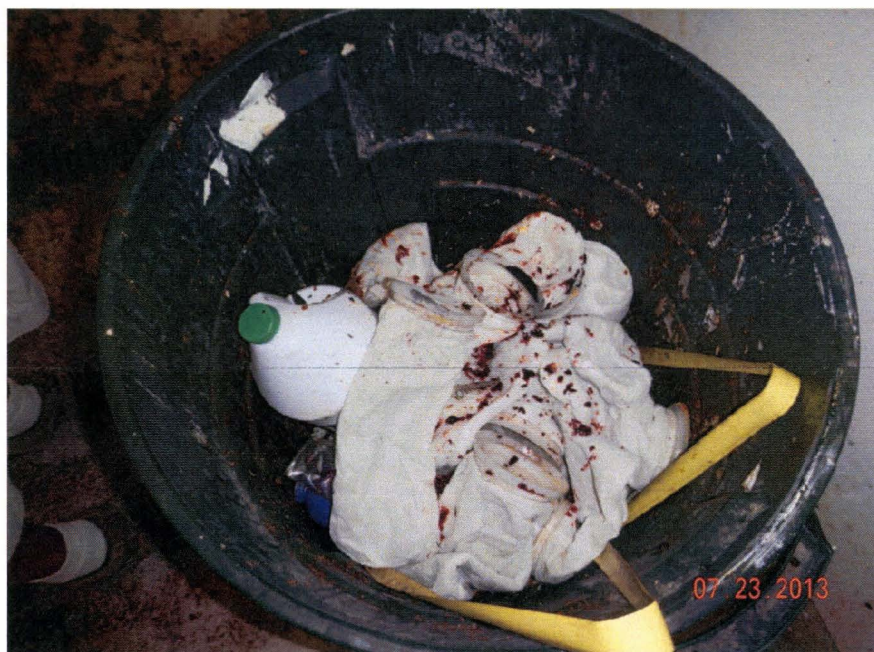
- **Spent Filter Socks** – Starting January 2011, the above filter resin column was discontinued and biodiesel fuel was filtered using four filter socks in series as shown in Figure 1. When the filter socks became clogged, they were removed and the residue squeezed out. The filter residue was added back into the process and the filter socks were reused. Also, some filter socks may be disposed with the general trash as were the approximately eight filters shown in photo 23. At the time of the inspection, I observed remaining on-site about six used filter socks in the Process Area and eight spent filter socks in the general trash as stated below in Section 4.5.1, Inventory Item #5 and Section 4.5.2, Inventory Item #4. **A hazardous waste determination had not been made on the spent filter socks as explained above. (NOV #1.5)**

**PHOTO 23**, 7/23/2013 – Report Section 4.5.1 Inventory Item #5 (spent filter socks). See attachment 6C for photo location. D. Newsome

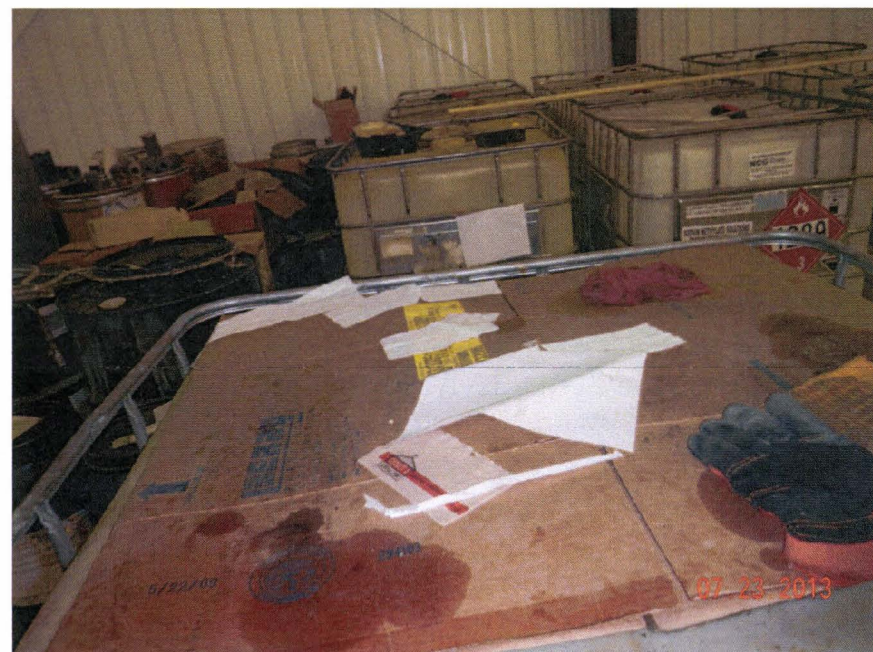
**PHOTO 24**, 7/23/2013 – Remaining Chemicals On-site – Close-up of face down "Waste" label lying on top of tote that was turned over by Mr. McCalla, see report Section 4.5.1 Inventory Item #6b. See attachment 6C for photo location. D. Newsome

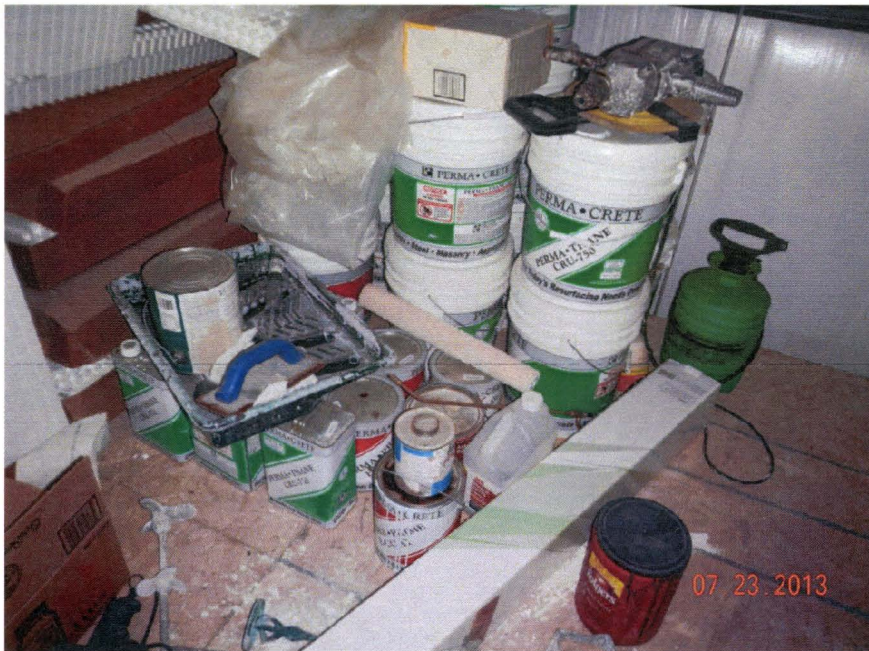
**PHOTO 23, 7/23/2013** – Report Section 4.5.1 Inventory Item #8 (paint related materials). See attachment 6C for photo location. D. Newsome

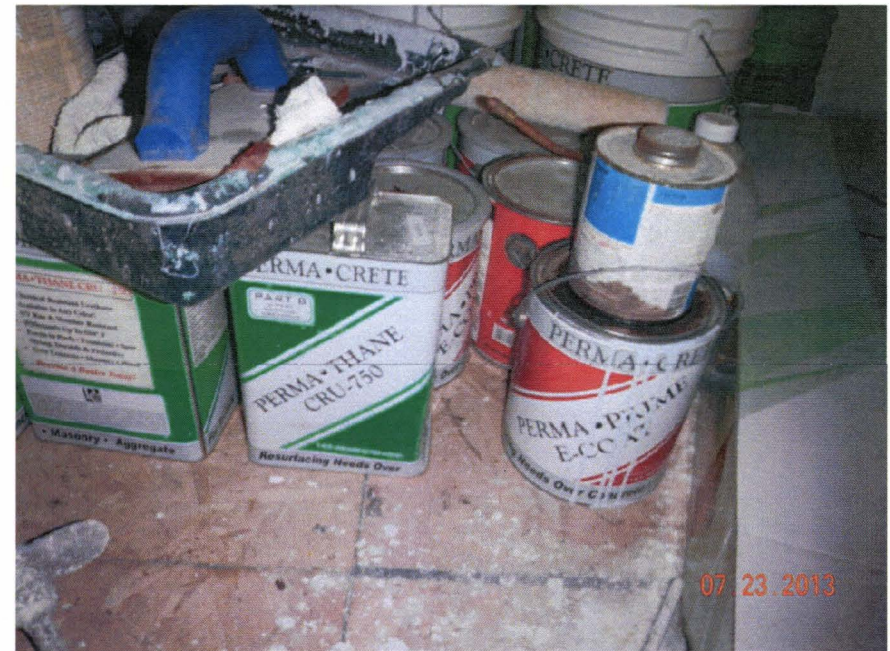
**PHOTO 23, 7/23/2013** – Close-up of report Section 4.5.1 Inventory Item #8 (paint related materials). See attachment 6C for photo location. D. Newsome

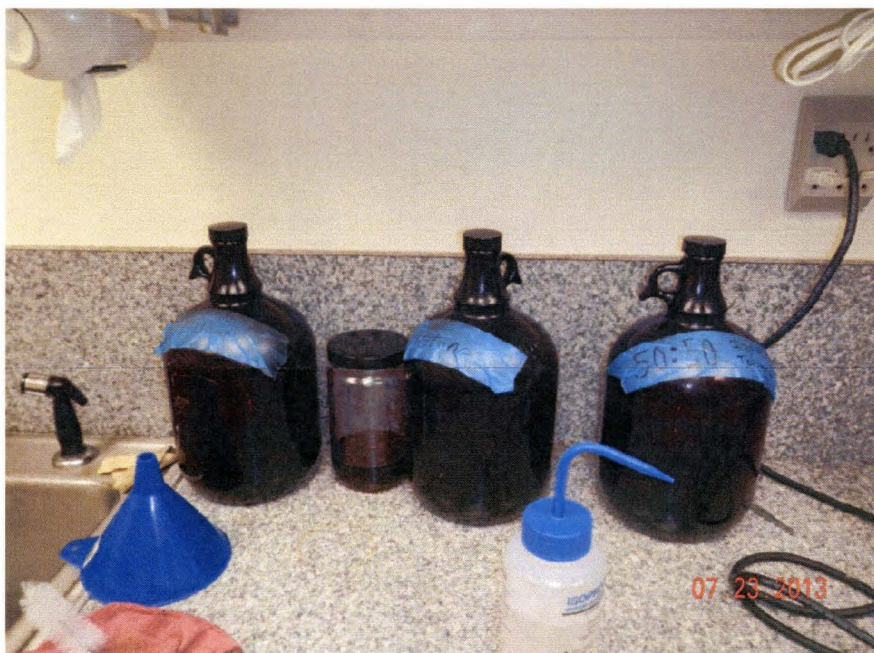
3. Lab chemicals and samples discussed above in Section 4.3.1 as follows:
  - a. Approximately 1/2 full 1-gallon jug of acetone (see photo 29).
  - b. Approximately 1/2 full 1-gallon jug of 50:50 isopropyl alcohol and toluene (see photo 29).

**PHOTO 29, 7/23/2013** – Lab Bench - Report Section 4.5.1  
Inventory Item #3a, 3b, and 3c.iv (lab chemicals). See  
attachment 6C for photo location. D. Newsome *DN*

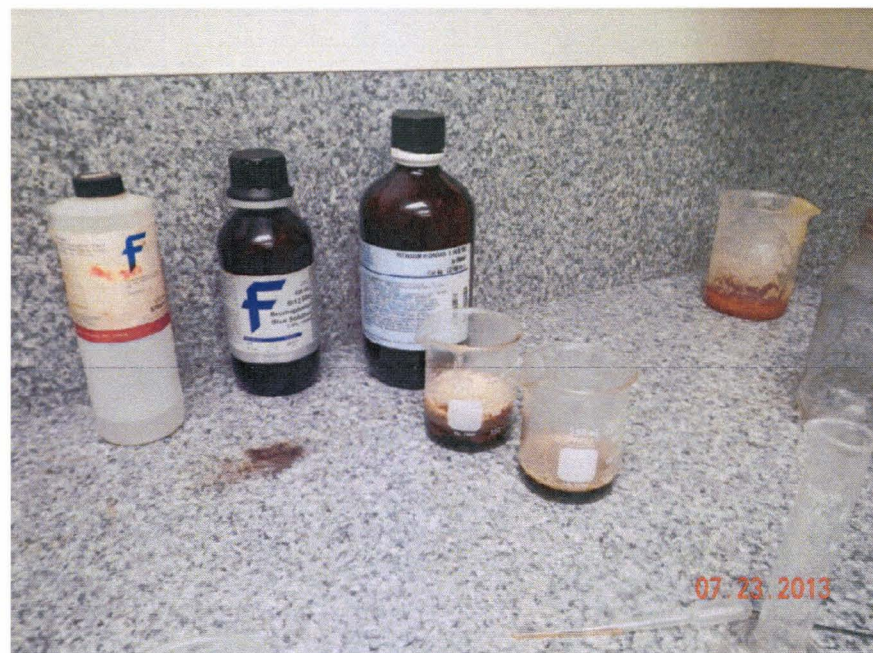
**PHOTO 30, 7/23/2013** – Lab Bench - Report Section 4.5.1  
Inventory Item #3c.i, 3c.ii and 3e (lab chemicals). See  
attachment 6C for photo location. D. Newsome *DN*
